# Successful Perimeter Fire Containment

Shedding light on common misconceptions about PFC systems

Sponsored by Owens Corning | *By Juliet Grable*

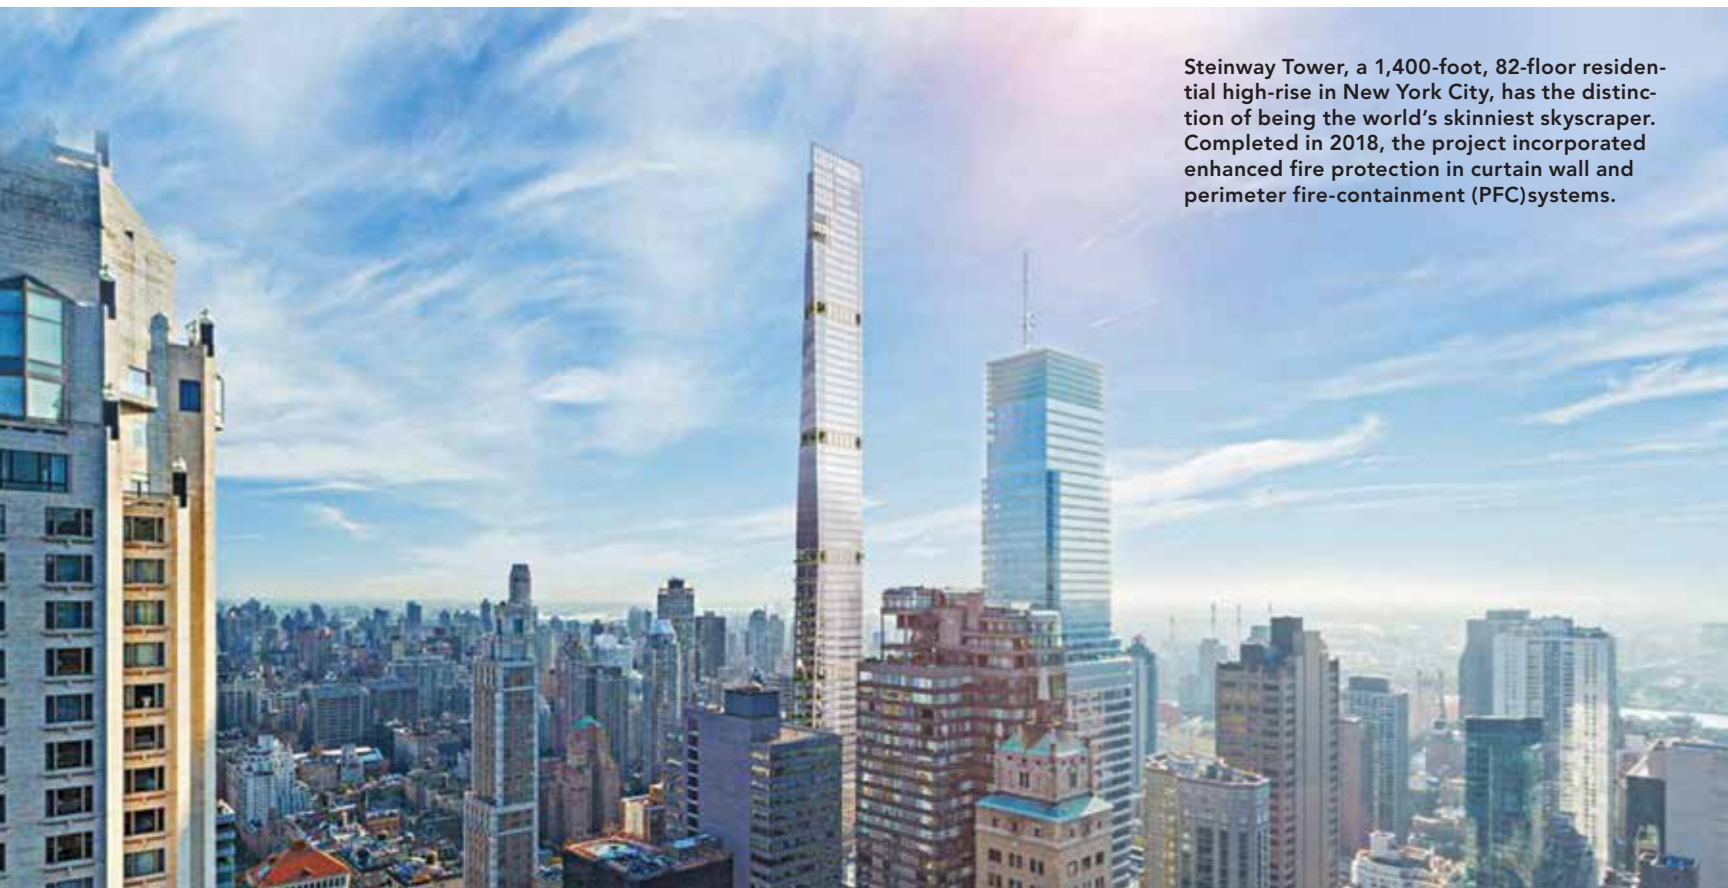
**Steinway Tower, a 1,400-foot, 82-floor residential high-rise in New York City, has the distinction of being the world's skinniest skyscraper. Completed in 2018, the project incorporated enhanced fire protection in curtain wall and perimeter fire-containment (PFC) systems.**

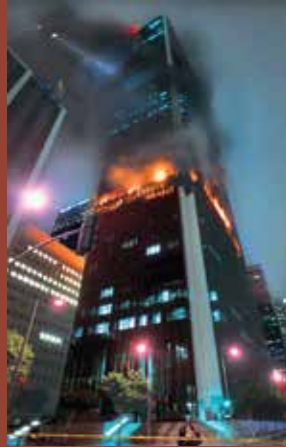
A fire that broke out on the 12<sup>th</sup> floor of the First Interstate Bank building in Los Angeles in 1988 illustrates how fire can rapidly propagate on building exteriors (see photo above). Flames spread through the unprotected joint between the curtain wall and floor slab, and once the heat broke the curtain wall glass, the fire leapfrogged up the outside of the building, eventually reaching the 16<sup>th</sup> floor. One person was killed and 40 people were injured in what was one of the most destructive U.S. high-rise fires in recent history. Properly designed and installed perimeter fire-containment (PFC) systems effectively seal off this pathway, limiting the fire to the room of origin and giving occupants time to safely evacuate.

It should be noted that a sprinkler system had been installed but was not yet operational, highlighting the importance of redundant active, passive, and detection systems.

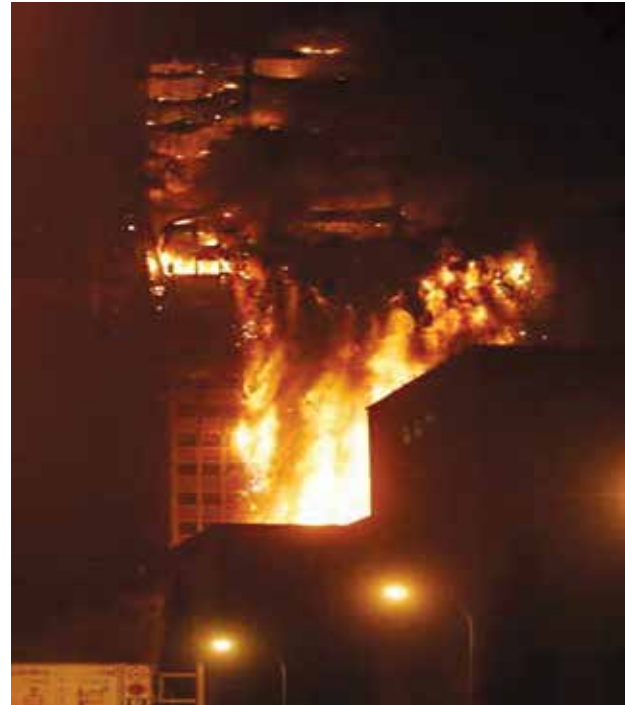
This photo of the Windsor Tower located in Madrid, Spain shows the results of “leapfrog” fire propagation. Note how the fire has spread vertically along the outside of the high-rise.

This is exactly what happened in the case of The Windsor. This high-rise was built at a time when building codes did not require the perimeter void to be protected. Conse-

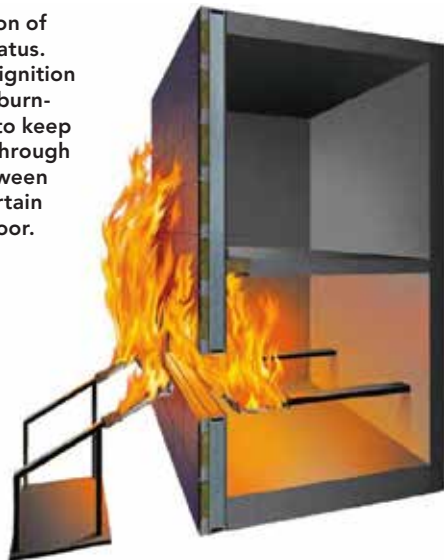
Shown is an illustration of the ISMA Test Apparatus. The test begins with ignition of first-floor interior burners. The objective is to keep fire from spreading through the interior joint between floor and exterior curtain wall on the second floor.

The ISMA structure is a two-story furnace that subjects a perimeter fire-barrier system to fire exposure from two sides at once. It is designed to simulate a building fire that originates on one floor and causes the windows to break, allowing the flames to escape the room of origin and impinge directly on the exterior of the curtain wall. The test focuses on the joint, which is protected by the PFC system. ASTM E2307 exposes the joint to fire from the room of origin and exposes the exterior wall to fire from both the interior and exterior as the fire plume exits the room through a window opening.

The fire originates on the first floor, or “burner room.” A second floor is located directly above the burner room and functions as the observation room. An interior burner is used to start a fire in the first floor room. Soon the room fills with flames and hot gasses. Approximately 5 minutes later, the exterior burner is ignited to simulate fire exposure on the outside of the building. When the vision glass on the first floor breaks, flames and hot gasses spread up the face of the exterior wall and through the joint

between the floor slab and perimeter curtain wall. The objective is to prevent flames and hot gasses from entering into the room above. If the fire breaks through the upper-story windows during the test, the system will have failed to compartmentalize the fire.

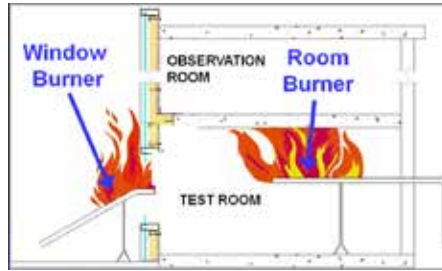
Shown is the intermediate scale multistory test apparatus used in the ASTM E2307 fire-resistance test.

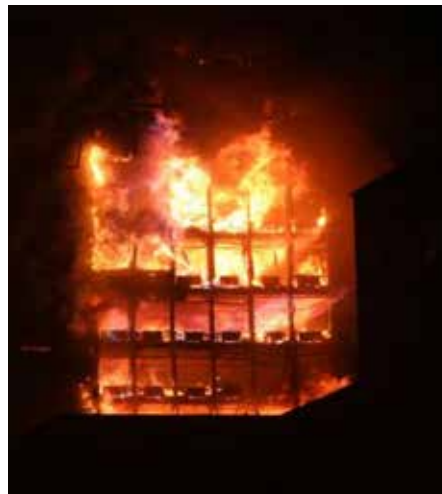
Notice the flame height attacking the exterior on The Windsor high-rise in Madrid, Spain, that was destroyed by fire in 2005.

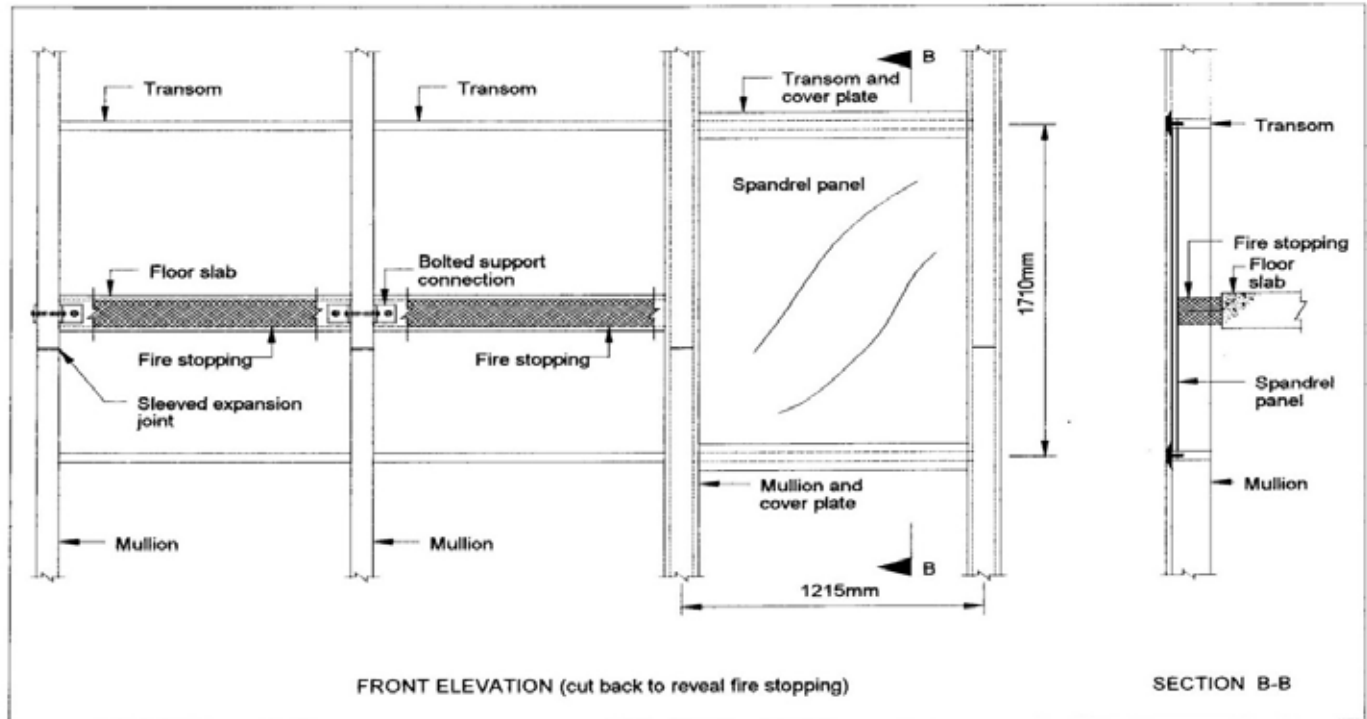
Figure 1 - Typical curtain wall system panel

Loss Prevention Council – United Kingdom 1999

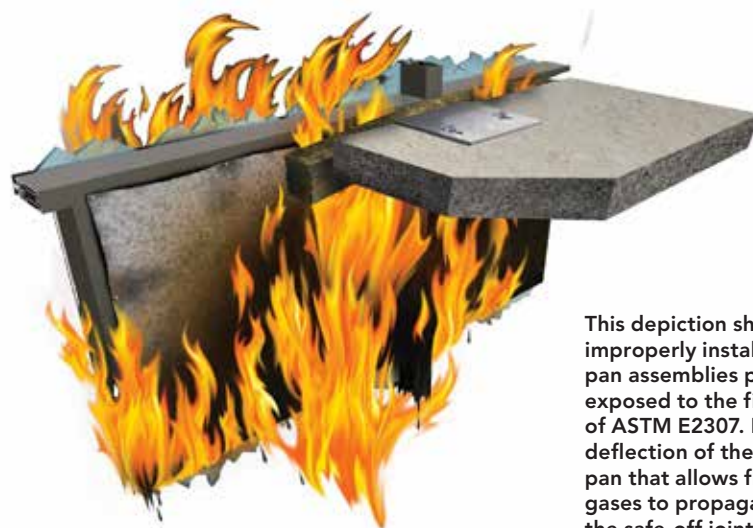
This depiction shows how improperly installed steel back pan assemblies perform when exposed to the fire conditions of ASTM E2307. Note the deflection of the interior back pan that allows flame and hot gases to propagate through the safe-off joint.

Back pans are galvanized steel sheets that are mechanically attached and sealed to the curtain wall framing around the perimeter behind opaque areas of a curtain wall. In these systems, the steel back pan serves as the vapor barrier. The use of steel back pans in PFC systems is becoming quite common because of the popularity of unitized systems; however, these systems must be properly protected. Even though steel does not melt, when exposed to elevated temperatures, the steel pan will buckle and warp due to its high expansion coefficient. When this occurs, the safing insulation cannot maintain its compression or follow the warping or deflection

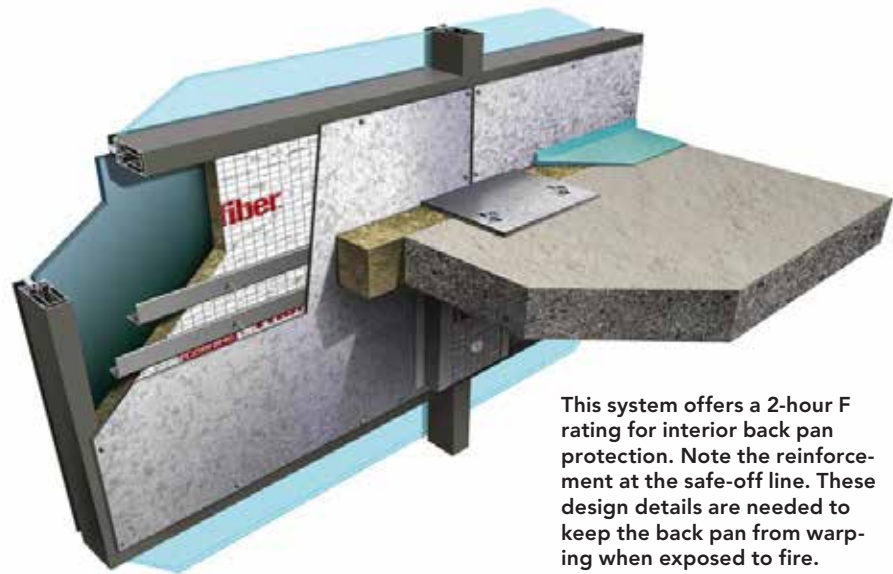
This system offers a 2-hour F rating for interior back pan protection. Note the reinforcement at the safe-off line. These design details are needed to keep the back pan from warping when exposed to fire.

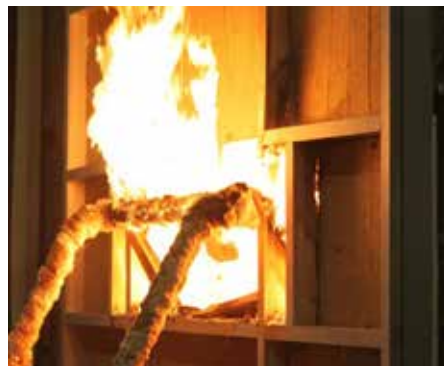
Shown here is mullion exposure to fire during testing. Note that the exposed side of the vertical mullion is almost completely melted out.

In 98 percent of all UL/Intertek tested and listed aluminum-framed curtain wall systems, vertical mullions within the spandrel area must be protected with UL/Intertek approved mineral wool mullion cover insulation. Aluminum will melt as early as 9 minutes into a fire. And yet, these aluminum framing members are critical for keeping the system together for the required hourly rating of the system. Typically, mineral wool spandrel insulation is mechanically attached to the mullions. If the aluminum framing is left exposed, it will melt and cause the mineral wool spandrel insulation to fall out or dislodge, which in turn can cause the mineral wool safing at the interior joint to become compromised and result in an early failure in the system.
